NPDES Permit Number: MAR10D585

Project Name: **Route 62 Roadway Resurfacing and Reconstruction**
Project Address: Route 62 Concord, Massachusetts
Project Proponent: **Town of Concord Public Works/ MHD**
Report Prepared By: Mary Trudeau, Environmental Consultant
Date of Report/Site Visit: October 30, 2009

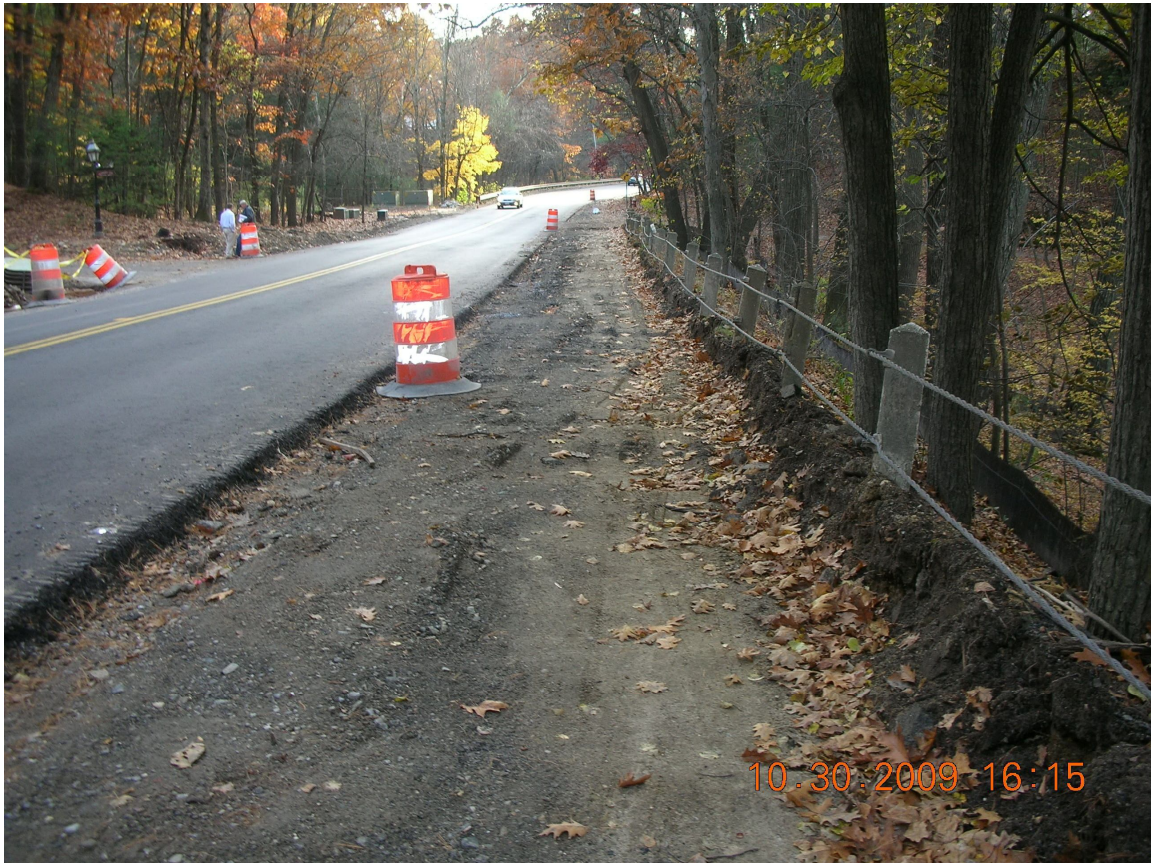
Weather this work week was seasonable with significant rainfall on October 28, 2009. At the date of my visit on October 23, 2009, it was apparent that work had progressed throughout the week. Work on drainage has continued, with many of the catchbasin and manhole structures being uncovered or reset. Curbing work is ongoing, and sidewalk grading along portions of the route continues. The following photo shows one of the sidewalk work areas located above wetlands on the north side of Route 62. Please note that the work area is cut into the shoulder of the roadway, with a protective berm above the erosion control fencing, visible below:

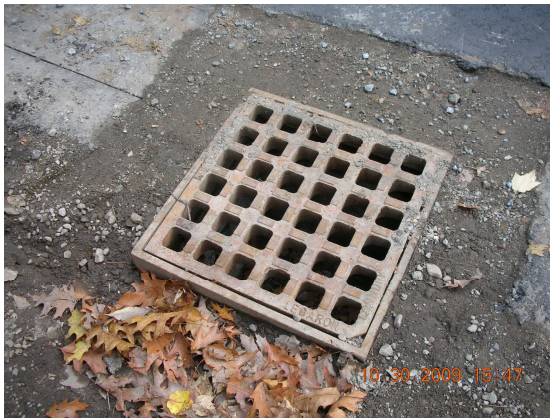
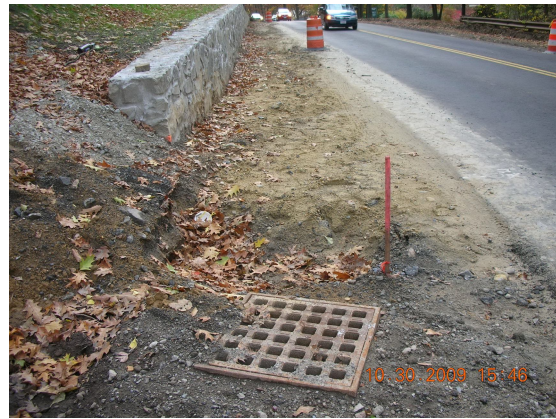
While catchbasin liners are not consistent throughout the site, I only found one open structure in an area likely to receive sediment laden flows due to current grading. The following photos show a typical catchbasin grate along the work route, and the photo on the right shows the basin of concern at approximately station point 25+75, on the north shoulder of Route 62. :

1. As catch basins are cut out of the newly paved areas, the contractor should install liners when unstabilized slopes will discharge sediment to the basins during rain events.

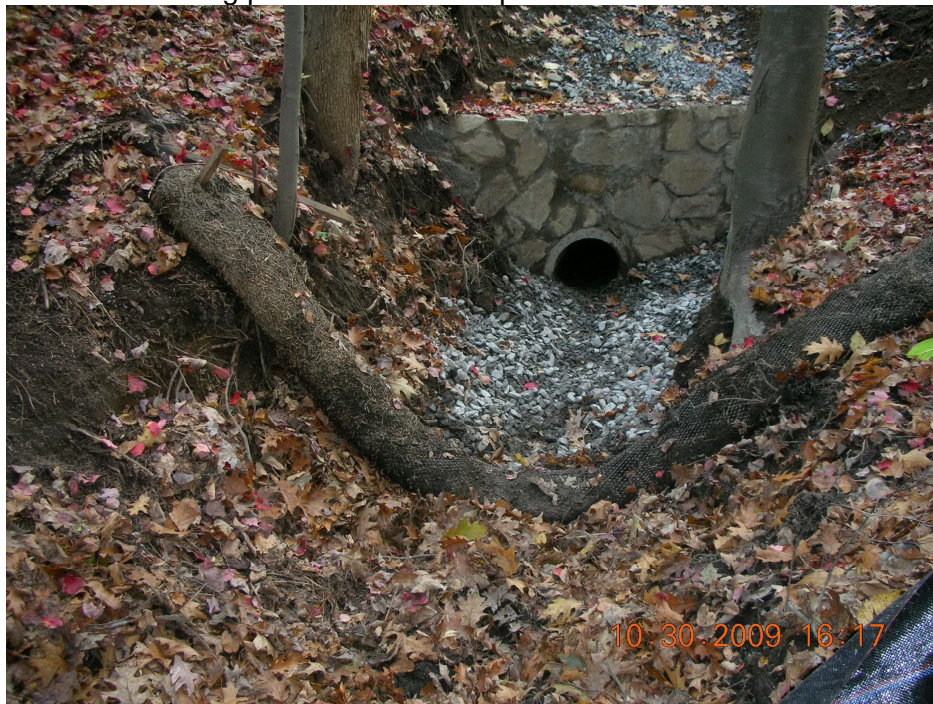
Two weeks ago, the contractor rebuilt the outfall on the north side of Route 62, located at station point 23+25. At that time I noted that while the shoulder has been rebuilt and is relatively stable, the work resulted in the deposition of fine silty sediment within the area between the culvert and the down gradient erosion controls. At my visit this week, I noted that the contractor had cleaned the channel, and installed crushed stone below the outfall. The following photo shows the improvements made in this area :

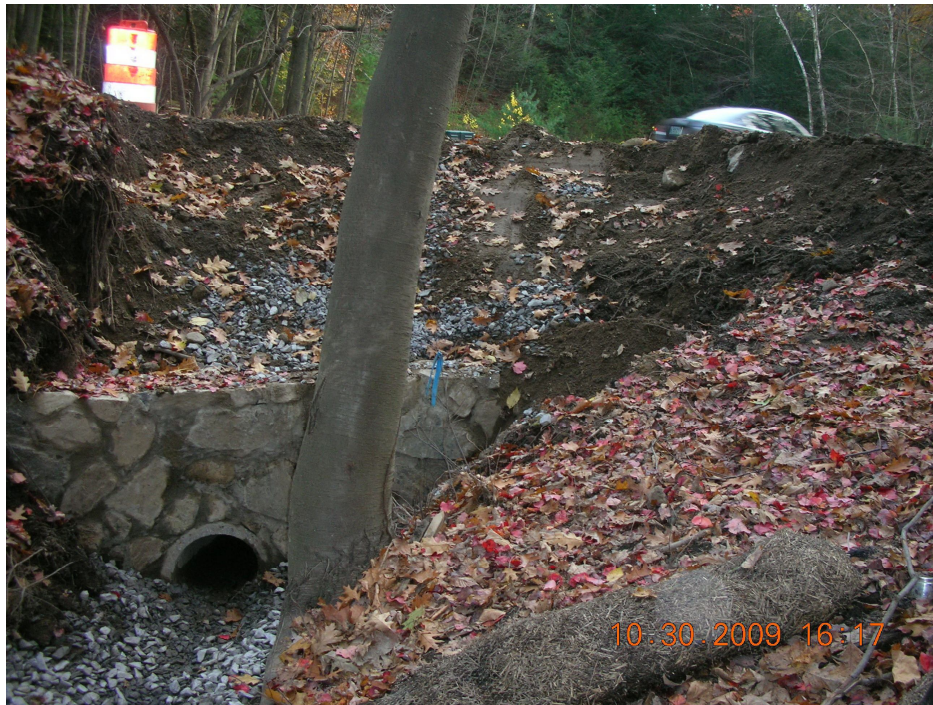
And the photo below shows the top of the headwall and the slope below the roadway. I would recommend that the contractor complete this shoulder work to minimize the deposition of material to down gradient areas:

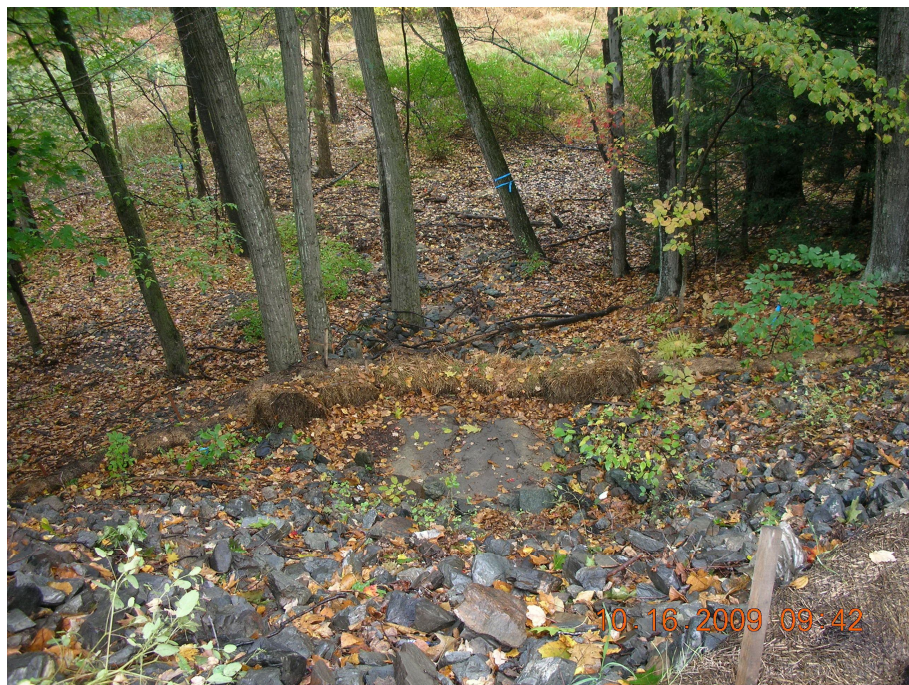
I continue to have some residual concern with the outfall at station point 15+00, on the north side of Route 62. With current pavement grading, the outfall does not appear to be receiving flows from catchbasins, but as noted in earlier reports, there has been some historic discharge of sediment to downgradient buffer zone and wetland resource areas. While the accumulations are not significant, the contractor should send a laborer to rake and remove any deposits of material. The following photo shows this area on October 18, 2009:

2. The contractor should address the sedimentation that has occurred down gradient of the drainage outfall at station point 15+00. Raking and hand work is the appropriate remediation.

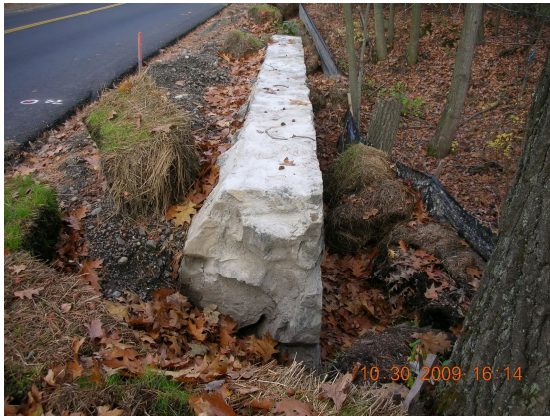
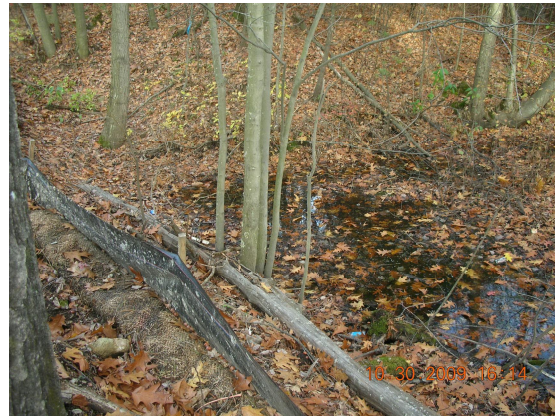
As noted in earlier reports, I am concerned with the upcoming detailing of the slope adjacent to either end of the easternmost retaining wall. This wall is located at approximately station point 27+50, on the south side of Route 62. I have spoken with Alan Visco of EH Perkins Construction and noted that I am concerned that the work should include stone and hand work to stabilize the area at either end of the wall. The contractor should insure, particularly on the eastern end of the wall (left hand photo below) that the materials used to stabilize the slope utilize the erosion controls for support. The toe of the finished slope should be set, and stabilized, at the back side of the retaining wall, and should not encroach onto the down gradient silt fence barrier. The following photo shows the areas of concern, and the second photo shows the clarity of the downgradient impounded waters within the wetland:

3. The contractor should consider the slope treatment of either end of the retaining wall at station point 27+00, on the southern shoulder of Route 62, and should plan on hand work in the more sensitive areas.

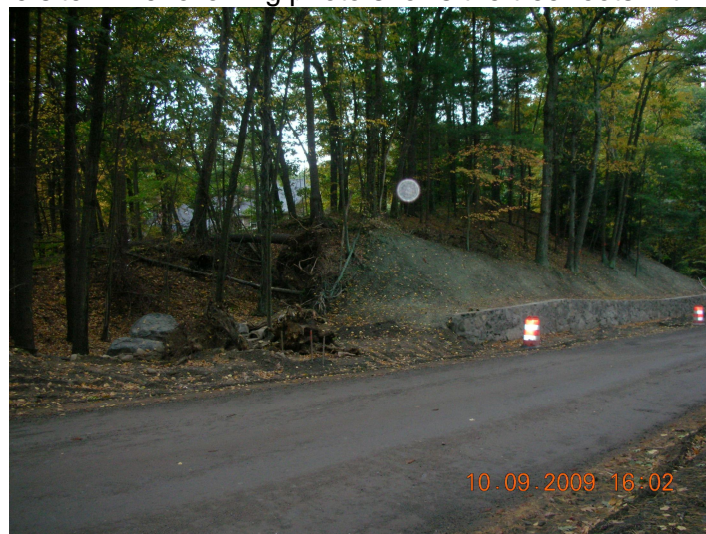
Also noted in earlier reports, Mrs. Sulewski, a condominium owner on Cranberry Lane noted that a tree fall at the south side of Route 62, at approximately station point 25+75 has fallen into and across her yard. Alan Visco and Minot Wood of EHPerkins Construction have determined that the tree fall is within forty feet of the centerline of the road (and is their responsibility) and that it will be cut and removed when the tree cutting crew returns to the site. The following photo shows the tree roots within the job locus:

4. The contractor should remove the tree fall at station point 25+75. It should be cut and removed from the site.
5. There is also a little pile of slash on the south side of the erosion controls at station point 28+25 (south side of Route 62) that should be pulled and disposed of off site. This was left by the tree cutters in the initial clearing of the site.
